PARKING and VEHICLE ACCESS

STORM WATER FACTS

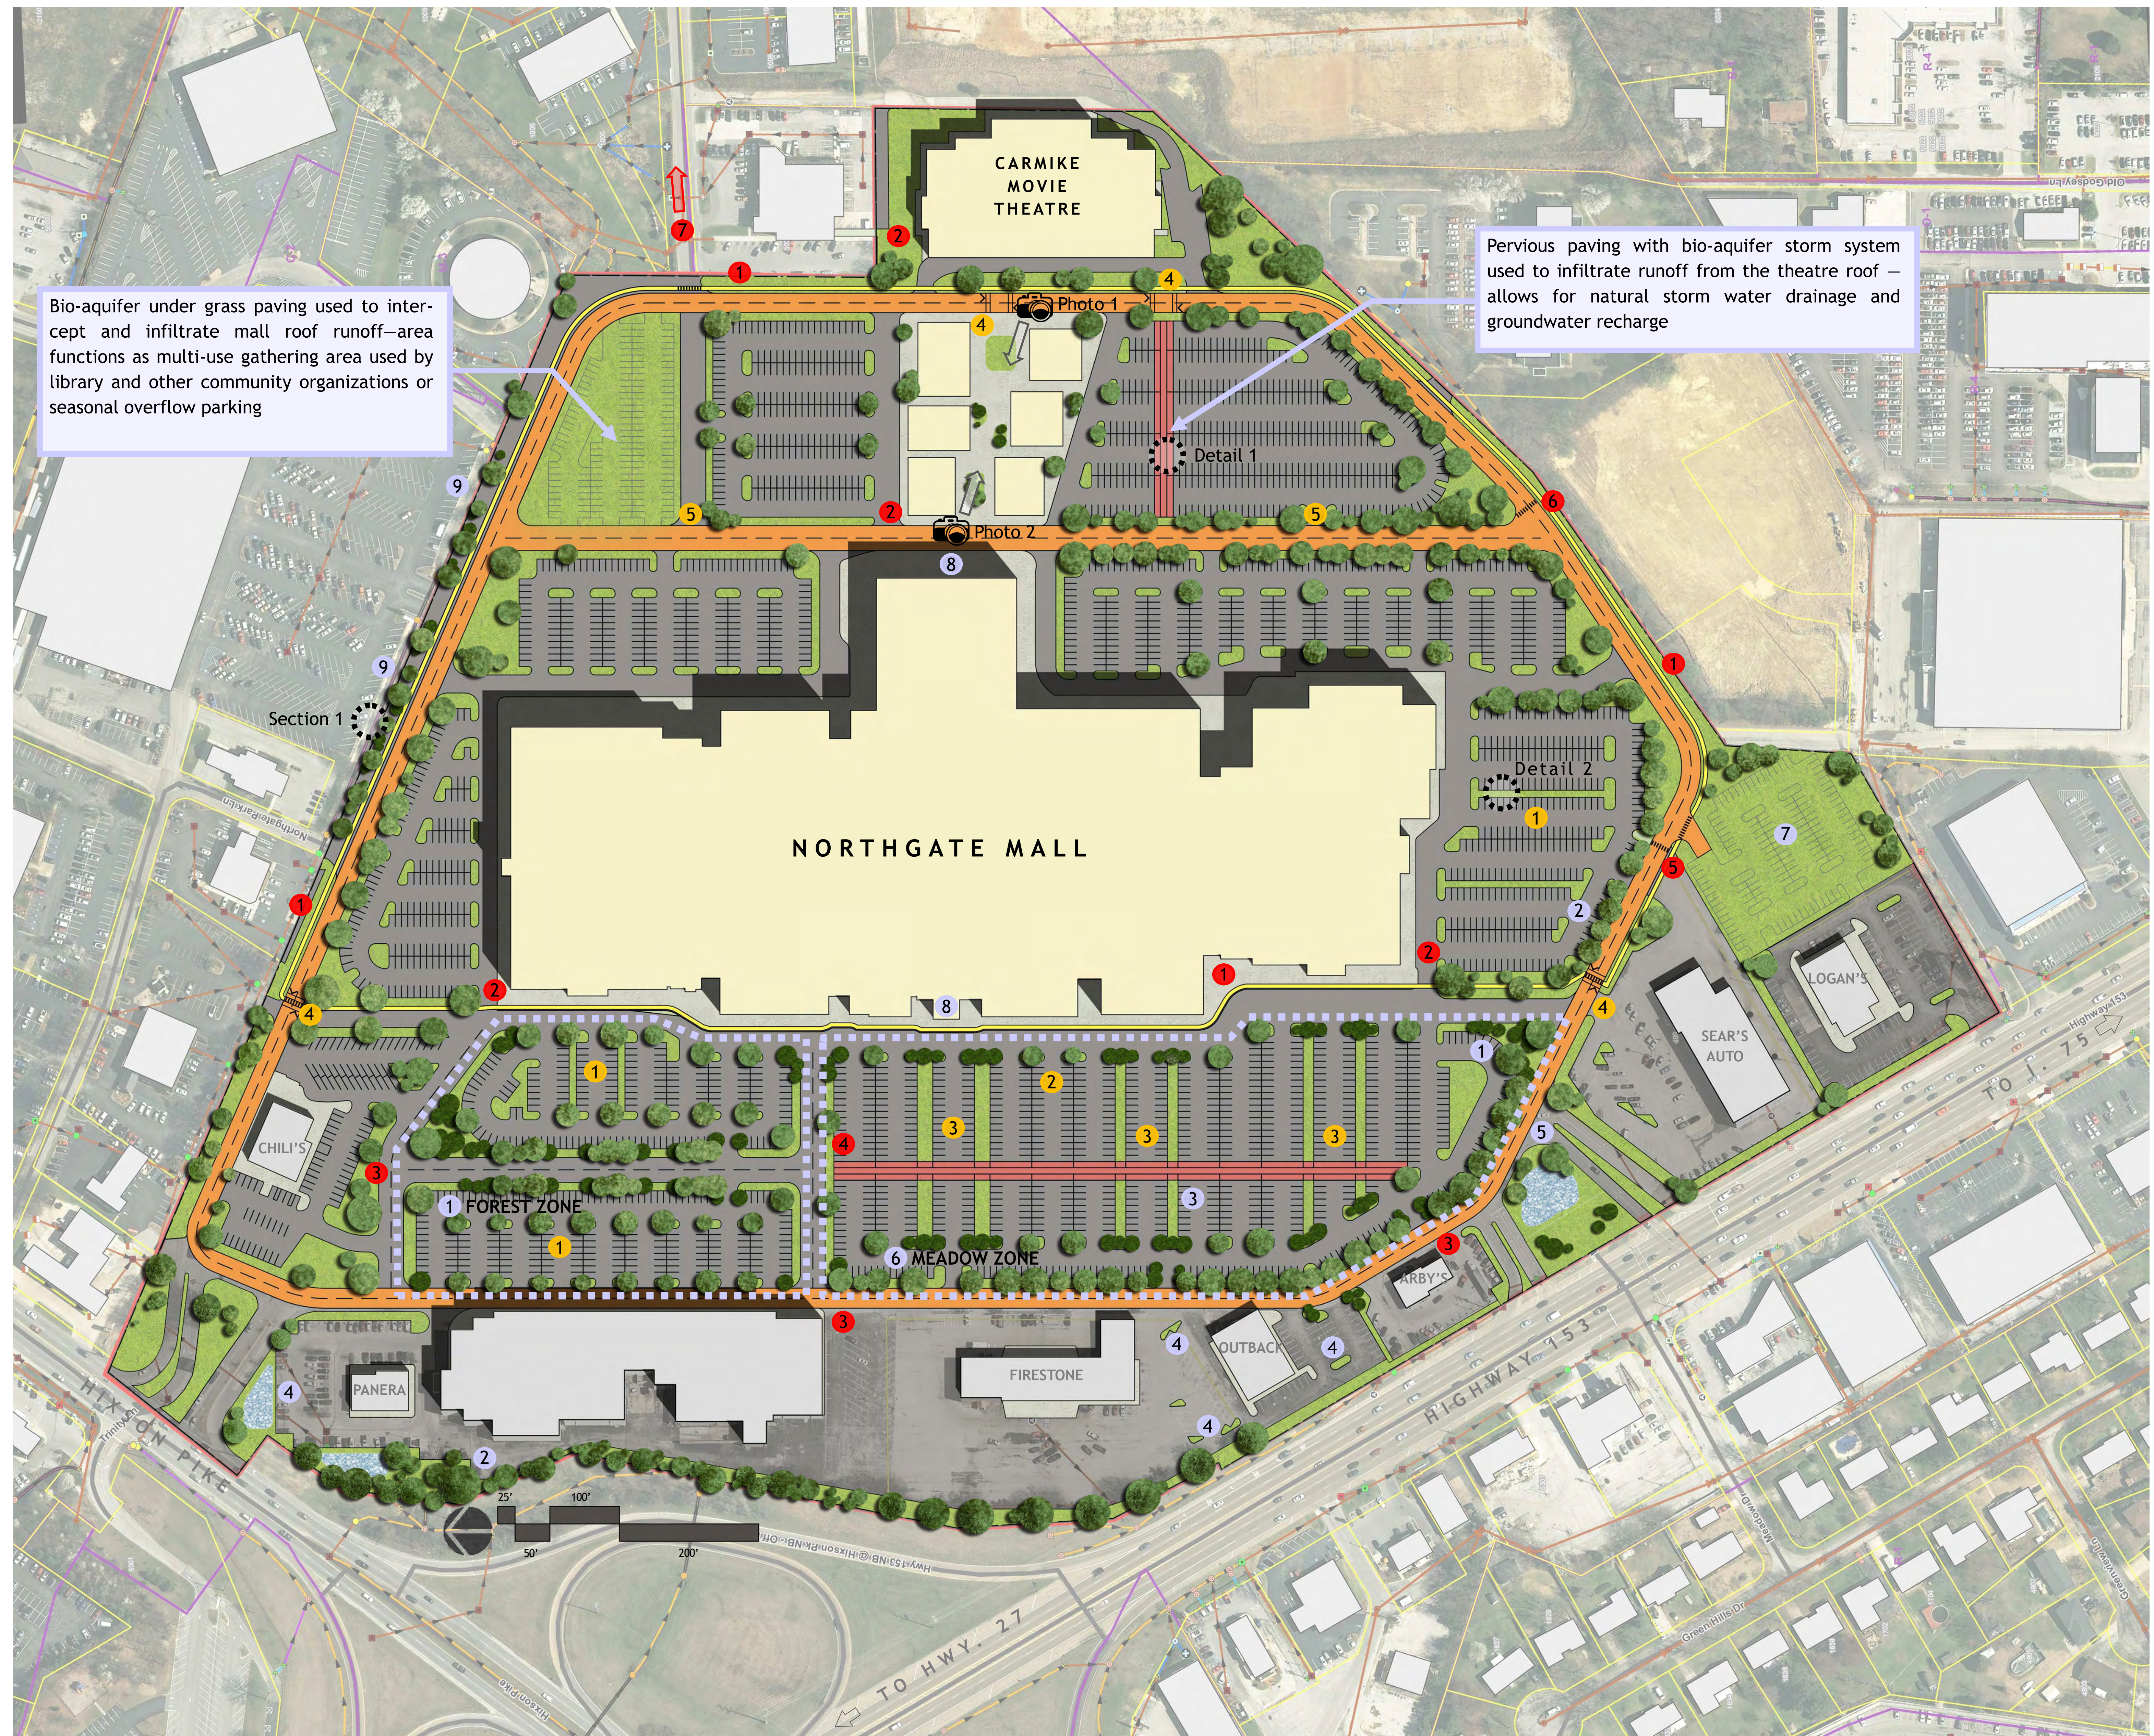
Bio-aquifer under grass paving used to intercept and infiltrate mall roof runoff—area functions as multi-use gathering area used by library and other community organizations or seasonal overflow parking

Pervious paving with bio-aquifer storm system used to infiltrate runoff from the theatre roof – allows for natural storm water drainage and groundwater recharge

- 1 Parking divided into smaller more focused lots
- 2 90 degree parking as more efficient use of impervious space
- 3 Longer medians on either side of drive aisle to create visual corridor to main mall entrances
- 4 Raised speed tables at pedestrian and bike crossings
- 5 Second collector drive to divide traffic into narrower roadways
- 6 Utilize existing asphalt paving throughout
- 7 Fewer vehicle lanes to encourage pedestrian circulation through shortened lane crossing distances

- 1 Forested micro-habitat areas for restorative SOV credits
- 2 Additional landscaping serves as an enhanced visual screen and pretreatment for runoff toward right-of-way and restorative volume credits
- 3 Pervious paving to intercept runoff and provide pedestrian route through parking lot
- 4 Retrofit existing parking median as bio-retention medians
- 5 Save existing established trees at entry and enhance with undergrowth species to create micro-habitat along new retention pond
- 6 Meadow micro-habitat areas for restorative Stay on Volume credits
- 7 Grass paving for seasonal overflow parking or community events
- 8 Planter boxes and living wall at main mall entrances
- 9 Stream restoration using living walls adjusting stream slopes to save existing trees – See Section 1
- 10 Maintain existing established tree vegetation throughout

- 1 8' Mixed use bike path connecting various areas around the mall campus
- 2 Bike racks
- 3 Bus stops
- 4 Protected pedestrian path between perimeter retail and mall
- 5 Crosswalks for access to overflow parking
- 6 Maintain and improve pedestrian access to neighboring property
- 7 Connection of mixed use bike path to proposed extension of Chickamauga Creek Greenway

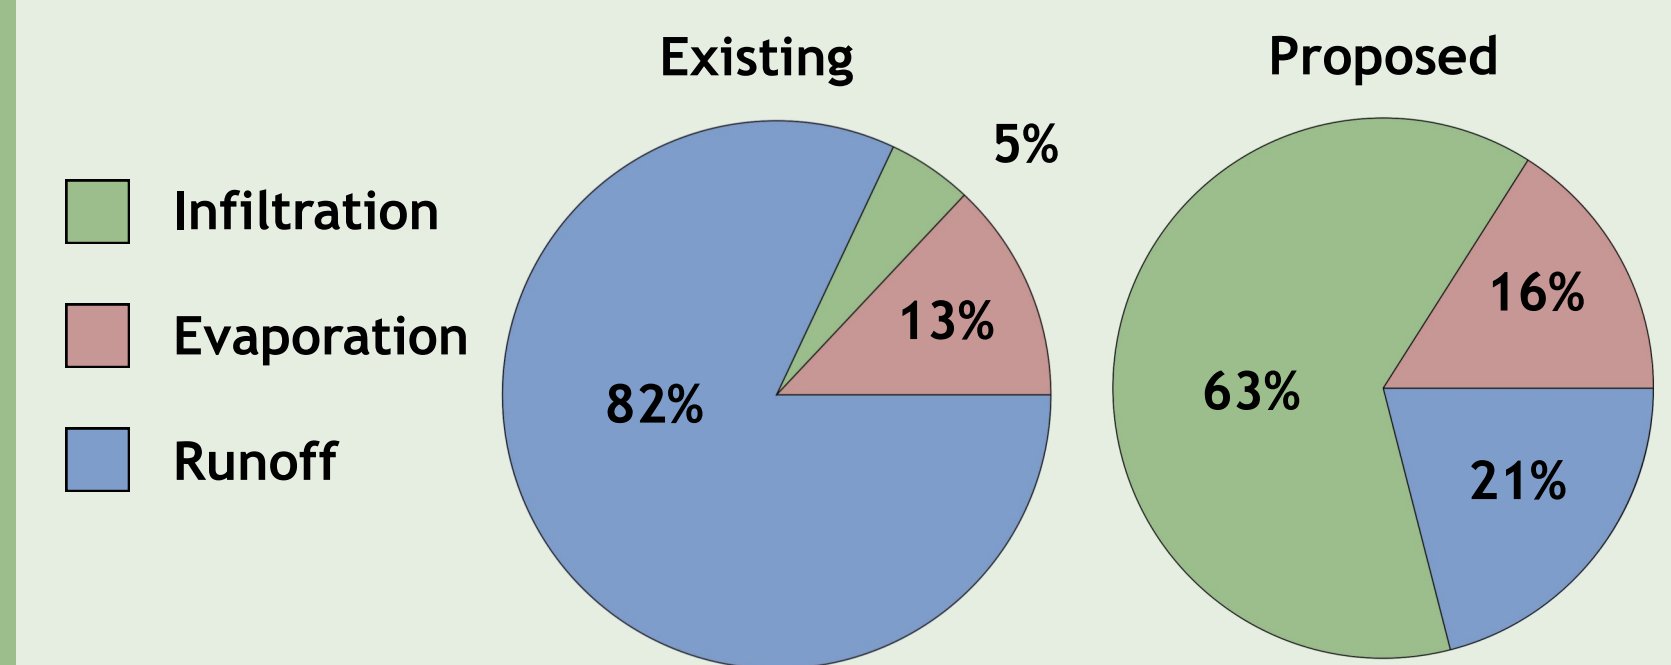
• With an average annual rainfall of 46.67", the current annual runoff from the site is 38.44". With the proposed changes, the **AVERAGE ANNUAL RUNOFF** will be **CUT BY 61%** reducing the amount to 9".
